FPSO Fracture repair and prevention of crack propagation

August 2020

Project type	Below the waterline crack repair
Area	5m ²
Design	12-25-E
Yard	On-station
Class	DNV-GL
SPS Partner	Marine Offshore Management

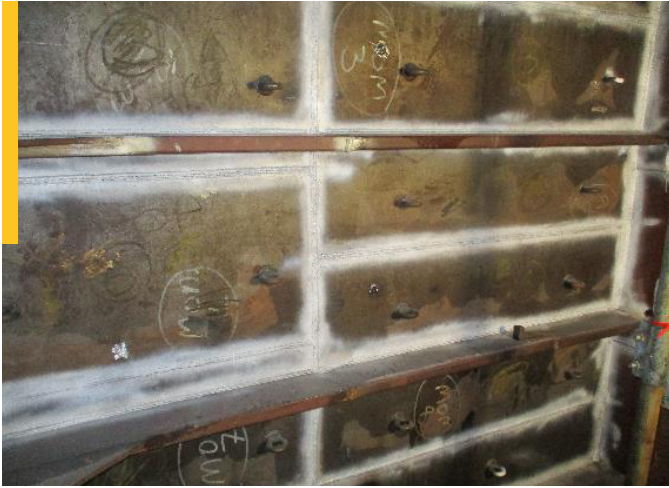
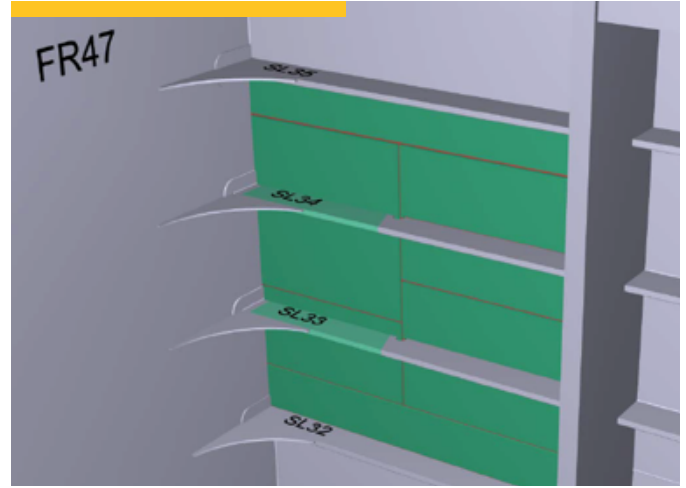
Marine Offshore Management (MOM), a key SPS Technology partner, was asked to provide a permanent repair and restore the integrity of a damaged (cracked) area of the hull structure. Doublers, previously used to provide a temporary repair of the cracks in the side shell were removed and two damaged longitudinal stiffeners cropped and renewed.

The composite construction of SPS enables the structural integrity to be restored by the SPS elastomer core transferring loading/stress levels from the existing plate to new SPS top plate therefore 'bridging the cracks'.

The SPS was applied from the inside with a 12mm top plate welded to the framing members. Most hot work took place away from the side shell. The SPS elastomer core was injected into the resulting cavity to form the composite sandwich.

SPS used the damaged plating as one side of the steel composite panel formed by a new top plate and an elastomer core. The resulting composite fully restored the strength of the original structure. SPS is approved by all major classification societies.
