FPSO Capixaba

June 2021

Project type	Cold Work Repair - Main Deck
Area	11m ²
Design	10-25-E
Yard	On-station, Offshore-Brazil
Owner	SBM Offshore NV Group
Class	ABS

FPSO Capixaba Deck Reinstatement

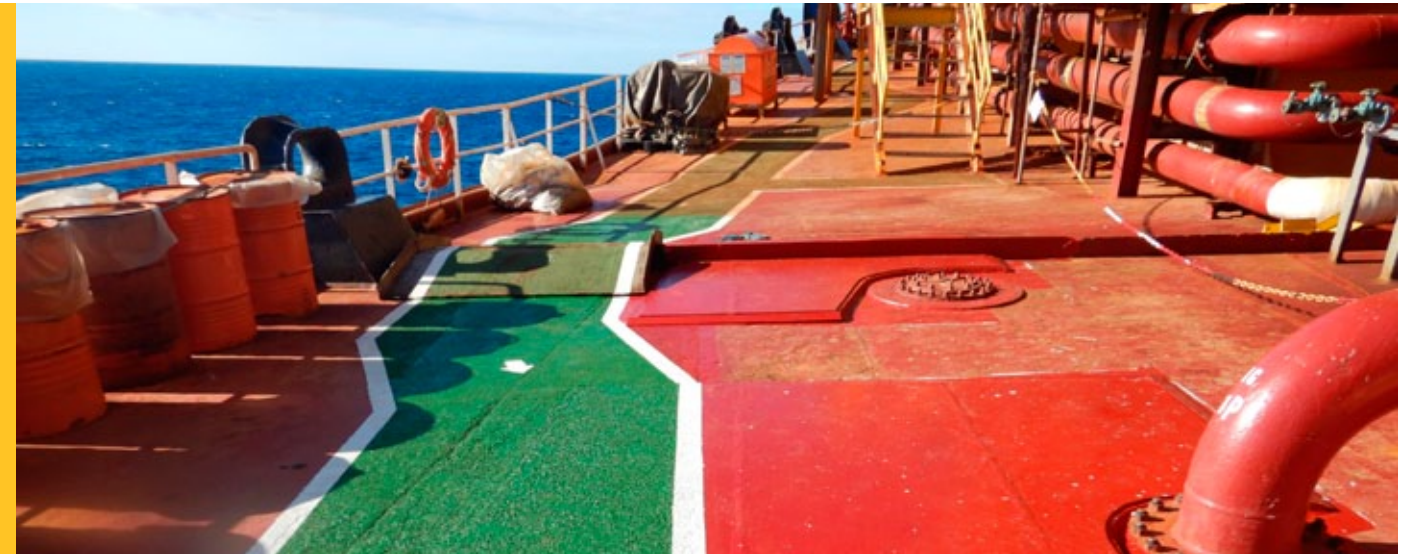
Excessive steel diminution had occurred on the Main Deck above the port cargo oil tank requiring local steel reinstatement. The FPSO Capixaba has the capacity to produce up to 100,000 barrels of crude oil each day, an important factor when choosing the method of repair. Unlike SPS, conventional in-situ repairs of this sort are slow and expensive and limit a vessels operating capacity.

The structural steel reinstatement of the Main Deck plating using SPS was carried out on-station by steelworkers from SPS partner, ASOM and SPS Technology's injection engineer. SPS enabled the FPSO Capixaba to maintain 100% operational capacity throughout the project, which took ten days to complete.

SPS Cold Work installation was used to deliver this permanent repair, reinstating the existing deck and creating a new composite section. A combination of bolts and structural adhesive was used to fit and join the steel components to form airtight cavities into which the elastomer core was injected. All steel components were prefabricated before shipping on-board for installation. This reduced the cost of the project, eliminated welding requirements, reduced time offshore for the installation team, which in turn, simplified project logistics. This design and process was evaluated and approved by ABS Brazil, locally.
