FPSO Fracture repair and prevention of crack propagation

August 2020

Project type	Below the waterline crack repair
Area	5m ²
Design	12-25-E
Yard	On-station
Class	DNV-GL
SPS Partner	Marine Offshore Management

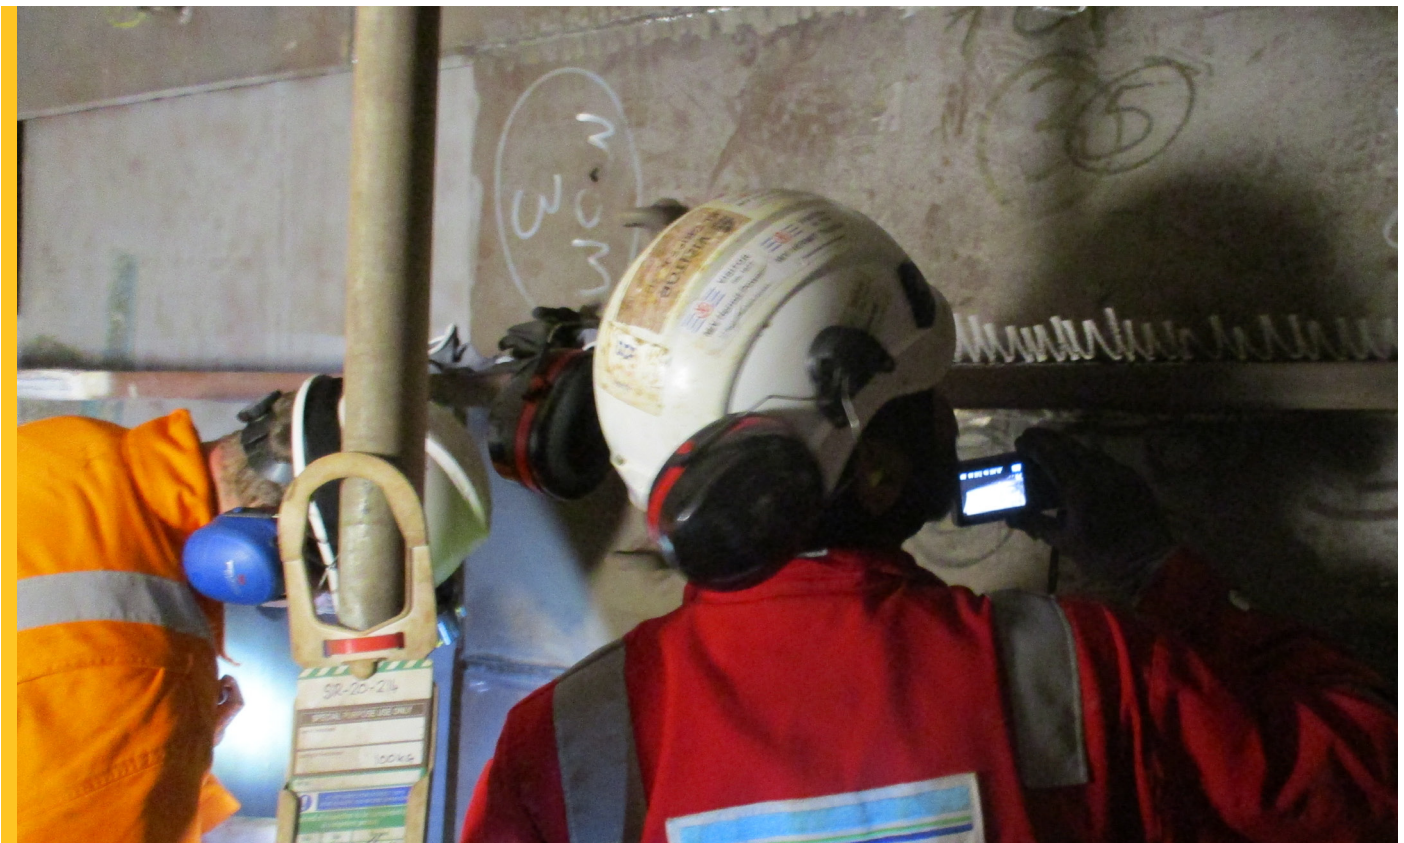
SPS® was applied on the starboard side shell in the diesel oil storage tank to provide a permanent repair and to restore integrity of a damaged (cracked) area of the hull structure. The project was carried out offshore whilst the unit remained in-service. The use of SPS resulted in:

Marine Offshore Management (MOM), a key SPS Technology partner, was asked to provide a permanent repair and restore the integrity of a damaged (cracked) area of the hull structure. Doublers, previously used to provide a temporary repair of the cracks in the side shell were removed and two damaged longitudinal stiffeners cropped and renewed.

The composite construction of SPS enables the structural integrity to be restored by the SPS elastomer core transferring loading/stress levels from the existing plate to new SPS top plate therefore 'bridging the cracks'.

SPS used the damaged plating as one side of the steel composite panel formed by a new top plate and an elastomer core. The resulting composite fully restored the strength of the original structure. SPS is approved by all major classification societies.
